Subject: Request for Closure Letter
Former Sunkist Citrus Processing Plant
616 E. Sunkist Street
Ontario, California

Project Summary
Former Sunkist Citrus Processing Plant

616 East Sunkist Street, Ontario, California

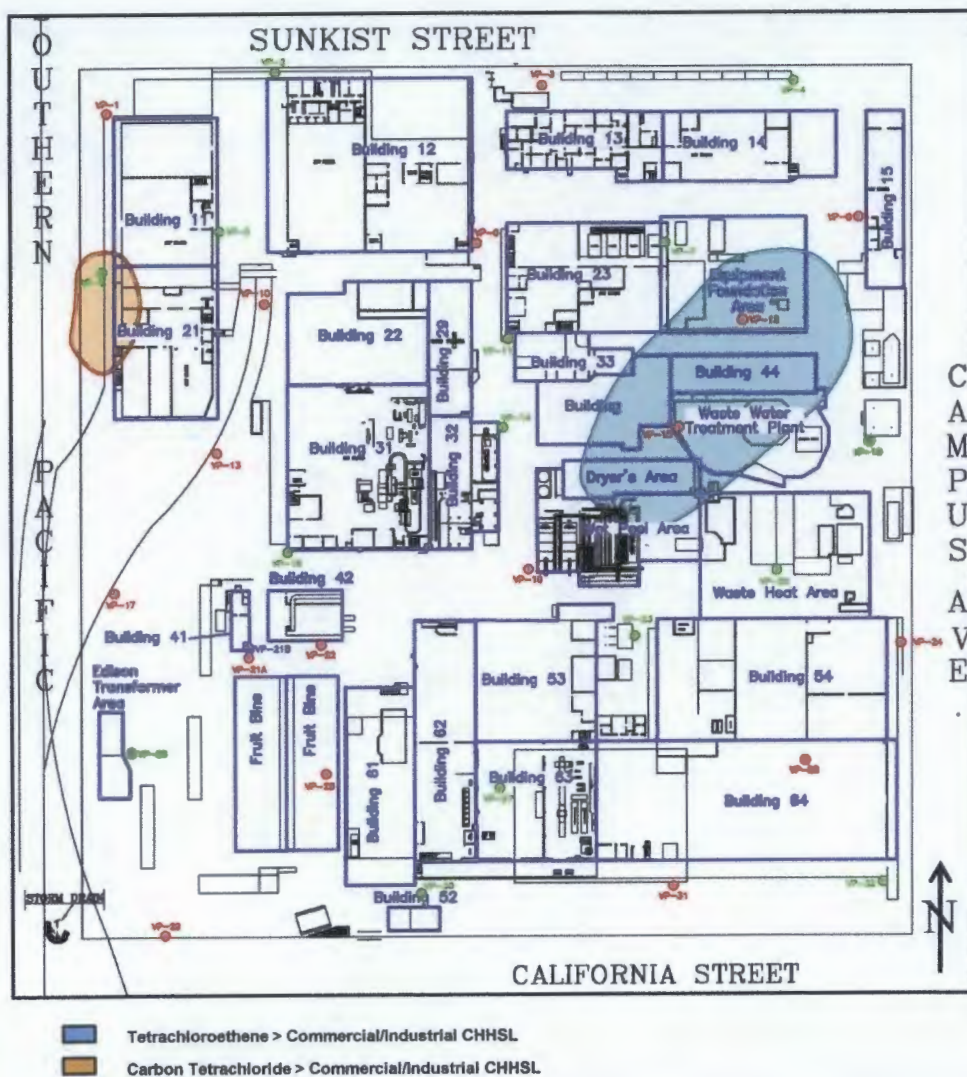
Slide 5

- Forty-eight Soil Vapor Samples.
- Installed in a Modified Five-Spot, 200 Foot Grid Pattern.
- Samples Collected at 5 and 15 feet below ground surface.
- Two 5.0 foot Samples Contained PCE Slightly Above Commercial/Industrial CHHSL.
- One 5.0 foot Sample Contained Carbon Tetrachloride Slightly Above Commercial/Industrial CHHSL.
- No Sample Contained Cumulative Carcinogenetic Risk of $> 1 \times 10^{-5}$.

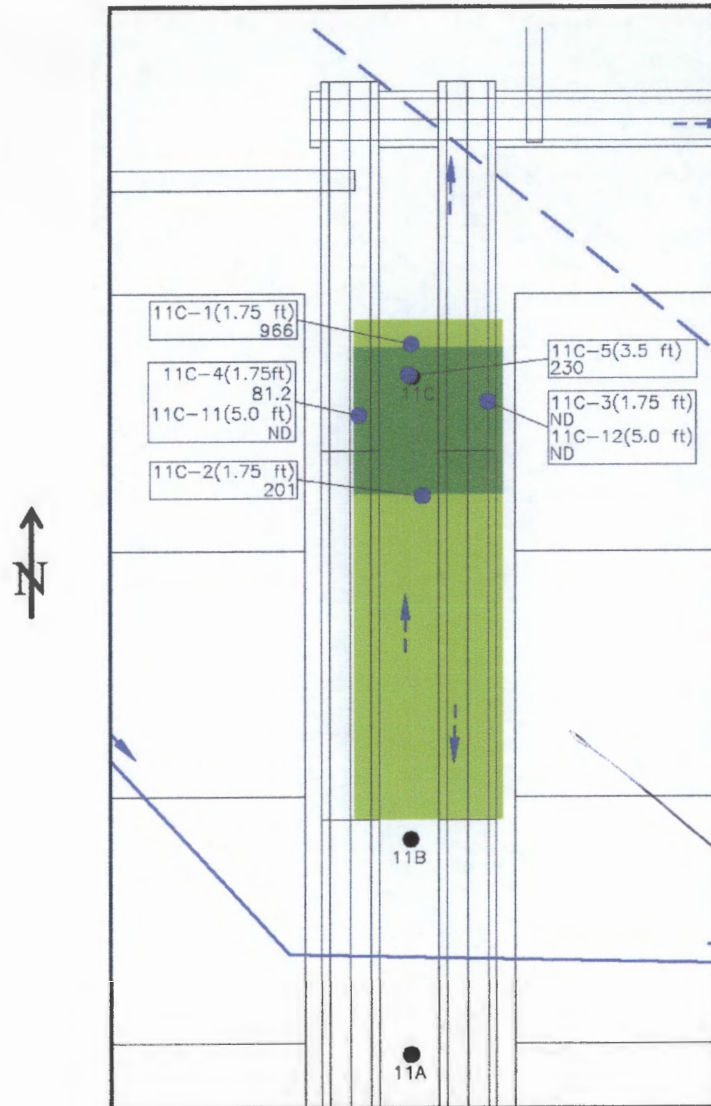
Slide 8

- **Aroclor 1260 at Concentrations in Excess of Commercial/Industrial CHHSLs.**
- **Two Rounds of Excavation and Confirmation Sampling.**
- **Final Set of Confirmation Samples Did Not Contain > Commercial/Industrial CHHSLs.**
- **Approximately 5 cubic Yards of Soil Excavated and Disposed of Off-Site.**

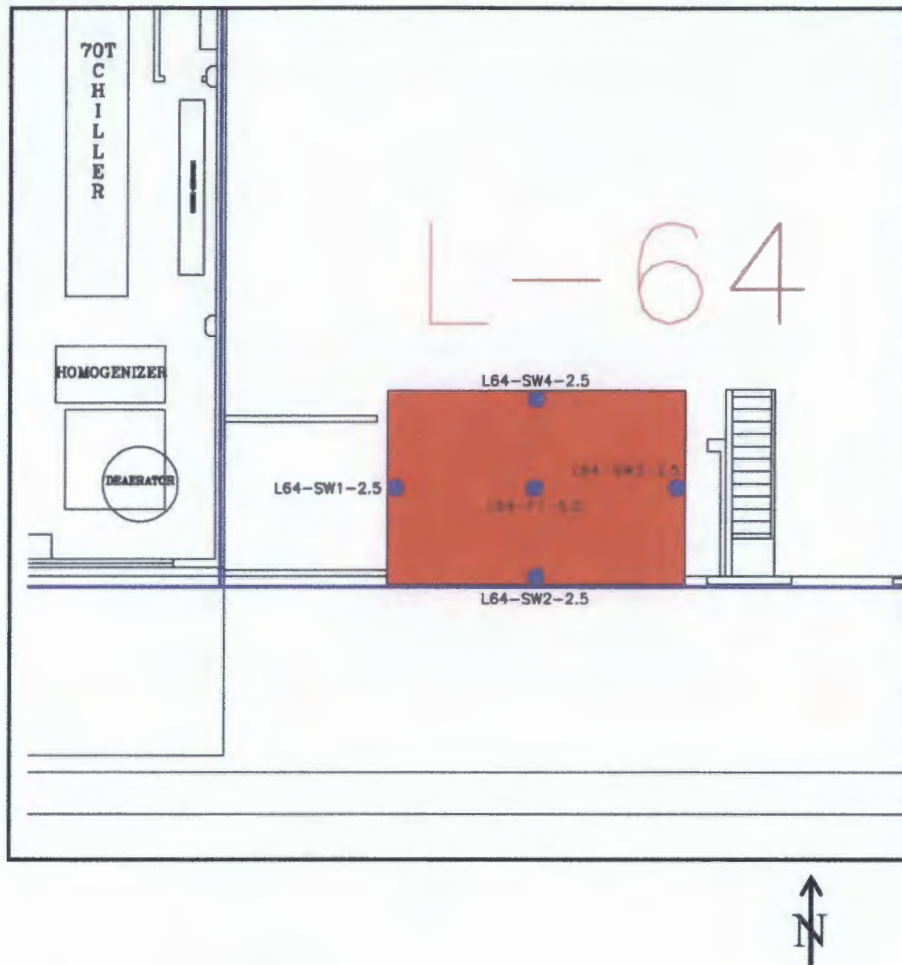
Backfilling contains PCBs.

- Demolition Plan Approved by City of Ontario (Buyer) Included Backfilling of Basements (Buildings 64, 11, 21 and 12) with Crushed Concrete.
- L-64 is Located in the Basement of Former Building 64, and Initial Sampling Results Showed the Presence of PCBs at Greater than Conservative Screening Criteria – As a Result an Accelerated Removal Action was Performed at This Location.
- Post Soil Excavation Confirmation Soil Sampling Results Showed Very Low to Nondetectable Levels of PCBs.
- County of San Bernardino Oversaw Removal Action and Authorized Backfilling of This Location.
